**US Army Corps  
of Engineers®**

**Facilities Condition Assessment  
Guam Memorial Hospital  
Tamuning, Guam**

**08 April 2020**

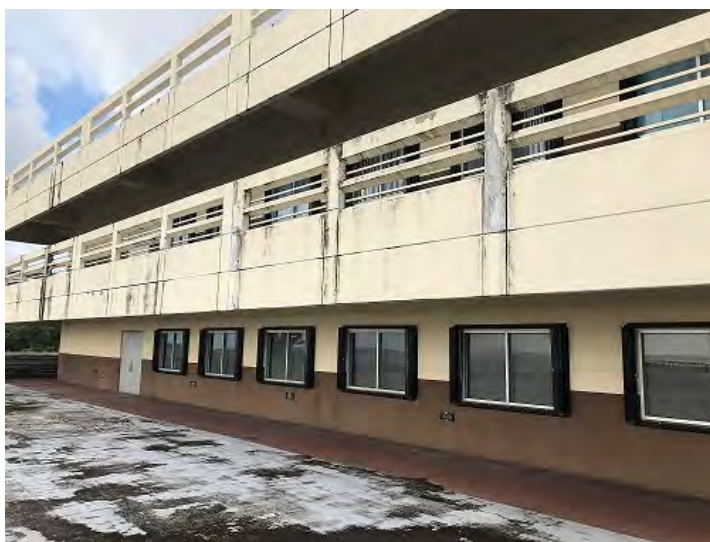
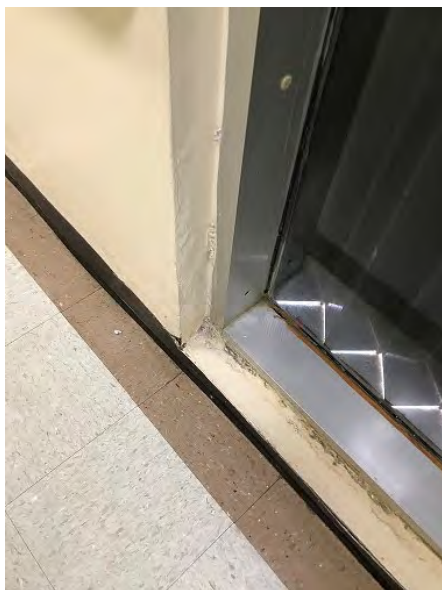
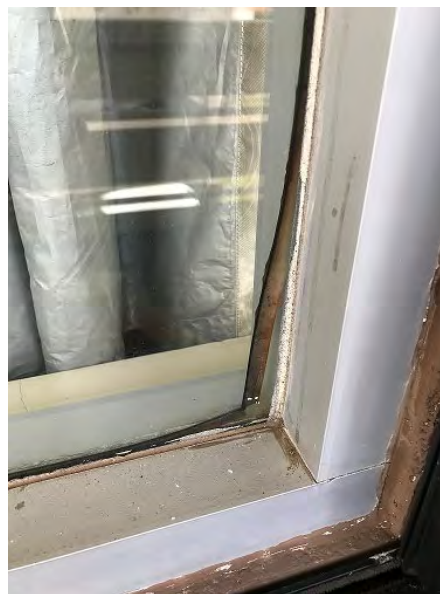
**Exterior Windows:** Exterior windows are generally in FAIR condition, constructed with single pane (fixed glass) aluminum framed systems either storefront or punched styles throughout the facility. All windows have a steel framed horizontal sliding metal (typhoon) accordion type

shutter system at the exterior. Numerous window sills have rot/decay/deterioration/water damage which appear to be leaking and should be replaced. Others have failed seals or gaskets. Windows that fail or are improperly sealed can cause heat and humidity to seep in, resulting in a rise of interior temperature, which will cause air conditioners to work twice as hard to keep the environment cool. This also creates moisture issues that can lead to the growth of dangerous substances such as mold.

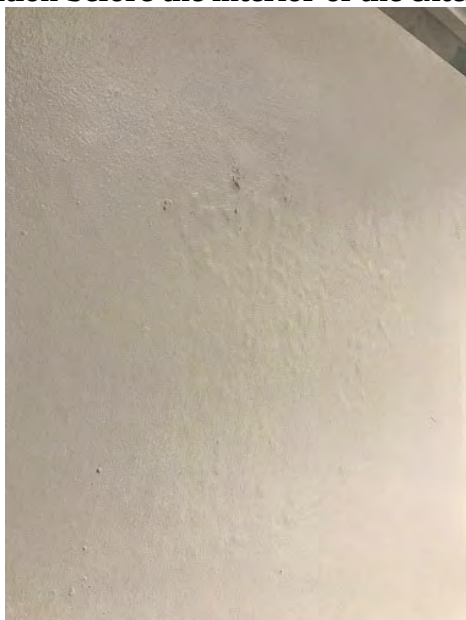
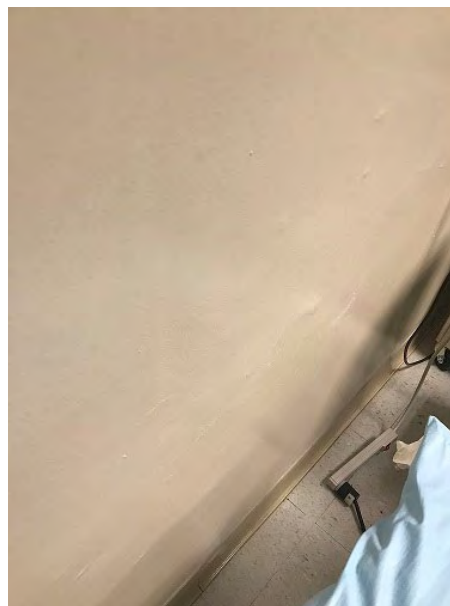
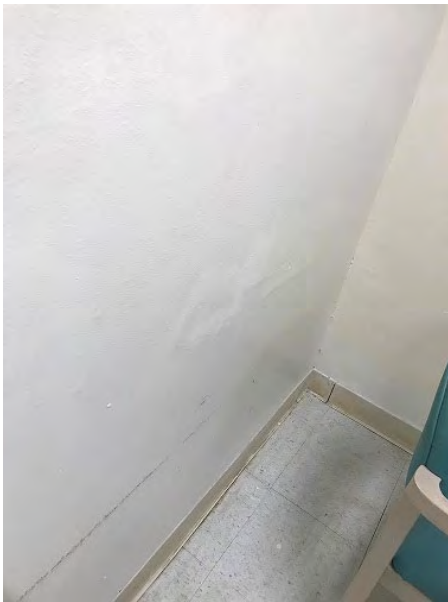
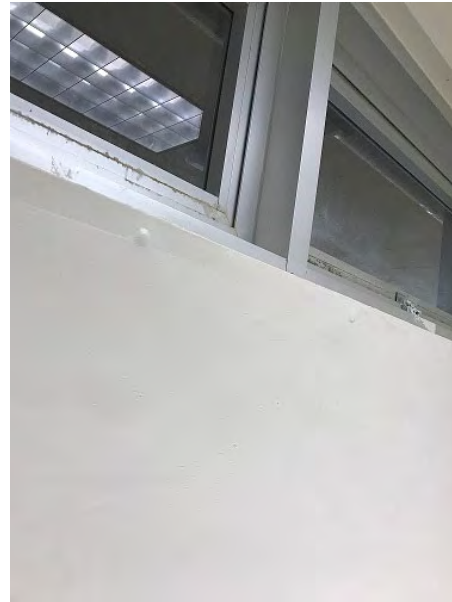
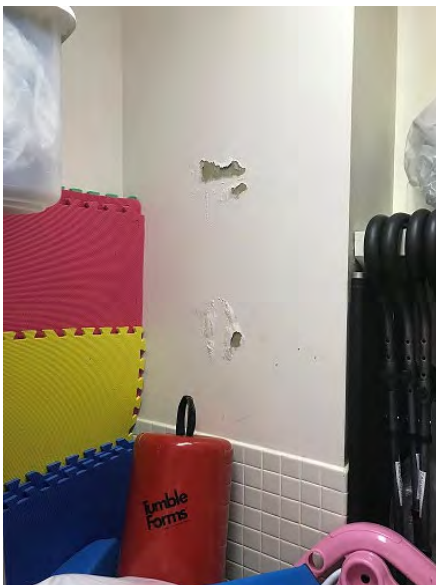
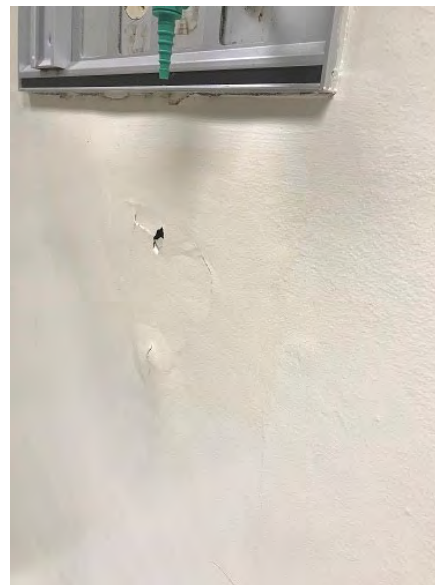
**Exterior Windows (Flashing/Weeps/Caulk):** Window sill flashing not provided and weeps at exterior are either not existent or sealed with caulk. Most architectural aluminum glazing system are not designed to be totally waterproof. Rather, most systems are designed to control water infiltration under extreme conditions and weep that water back to the exterior. Punched windows, storefront and curtainwall systems differ in many ways: appearance, profiles, wind loads, glazing, thermal performance and how they weep water. **Punched window** can be

**PRIORITY Repair:** Recommend first and foremost that the exterior windows throughout the facility be replaced with better quality, energy efficient systems with properly installed flashing. As well as the AHU and building pressurization correction (positive). Once that is done, remove damage areas/sections or entire interior wall would be warranted based on severity of damage. The exterior envelope must be sealed with the correction of water infiltration before the interior of the exterior walls can be repaired/replaced.

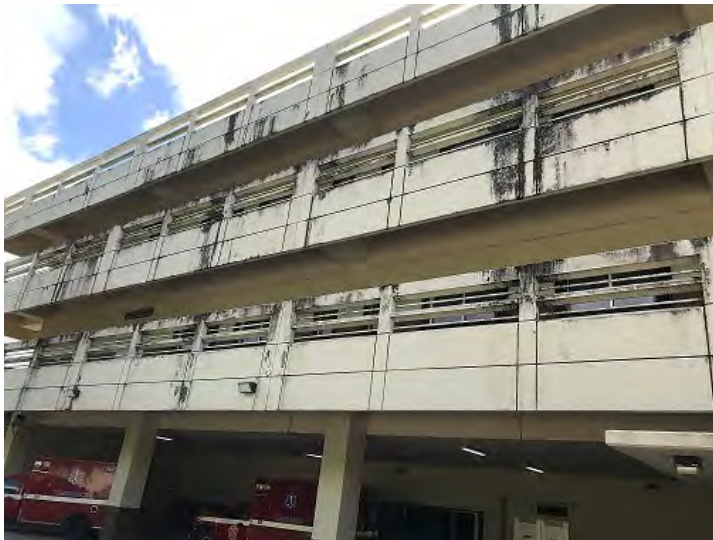
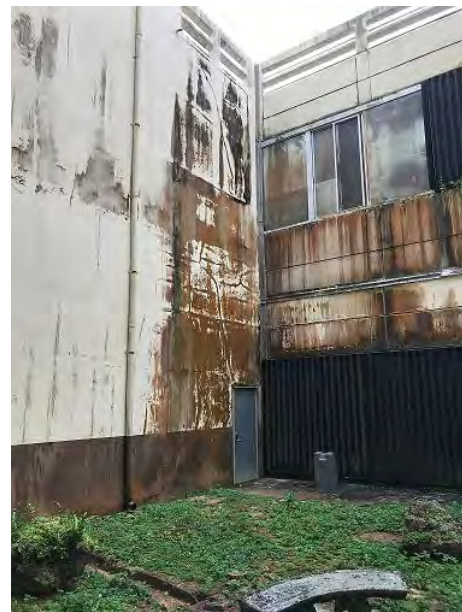
**Exterior Wall Finish/Cleaning/Painting:** The majority of the buildings has a significant amount of mold growth, peeling paint and discoloration on the exterior surface. The exterior wall itself appears to be in GOOD condition. Guam is located in a tropical extreme humid location. Although some of the mold may be located on the surface, other areas appear to be more significant. Mold feeds on organic materials, such as wood, paper, many fabrics, and even some types of glue. It literally eats away at these materials, causing them to rot and fall apart. Outside mold does not always stay outside. It will eventually find its way thru the envelope and into the building. Outside mold does carry health risks, but the risks are not as great as with inside mold. Although the concentration of mold will be less outside in the open air than it would be indoors. However, that doesn't mean exterior mold cannot lead to health problems. If someone

This mold may be caused from the moist humid conditions/environment, low quality paint, from an inferior, damaged or missing vapor barrier or simply the exterior materials used. Another influence, could be negative pressure rooms located at/near the exterior wall drawing the moisture into the building. Buildings in general should be positively pressured. The GMH facility is actually under negative pressure. **MAJOR SCHEDULED REPLACEMENT (MSR)**  
**Repair: Recommend that the entire exterior of the facility be sprayed with chemicals to kill the mold, power washed, then sealed, caulked and painted with a high quality mold resistant paint. Implement a mold prevention/ maintenance plan to clean the exterior regularly.**

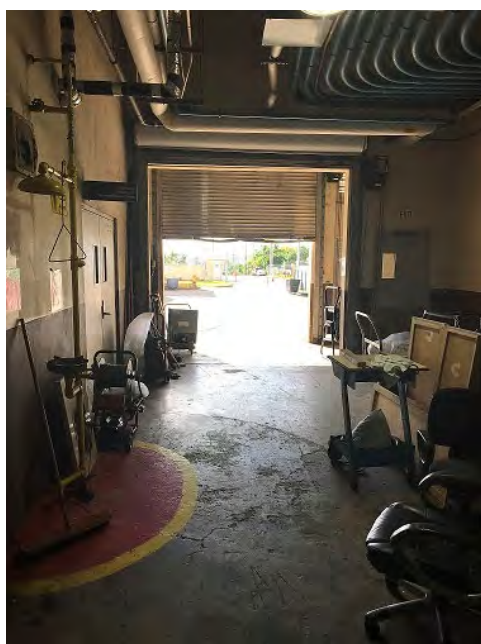
**Exterior Doors:** Exterior doors have a mixture of either aluminum or hollow metal. Majority of the original building doors are in GOOD condition. Typical door frames are hollow metal. The only issue identified are failed seals probably due to exposure and corrosive environment. A couple of the overhead doors at the central utility plant also needs to be replaced due to condition and damage. **PRIORIT Repair: Recommend replace all man door seals, recondition hardware to either full replacement of overhead coiling CUP doors to reconditioned (oil/lubricate) to replace latches, wheels, bearing and coil springs.**

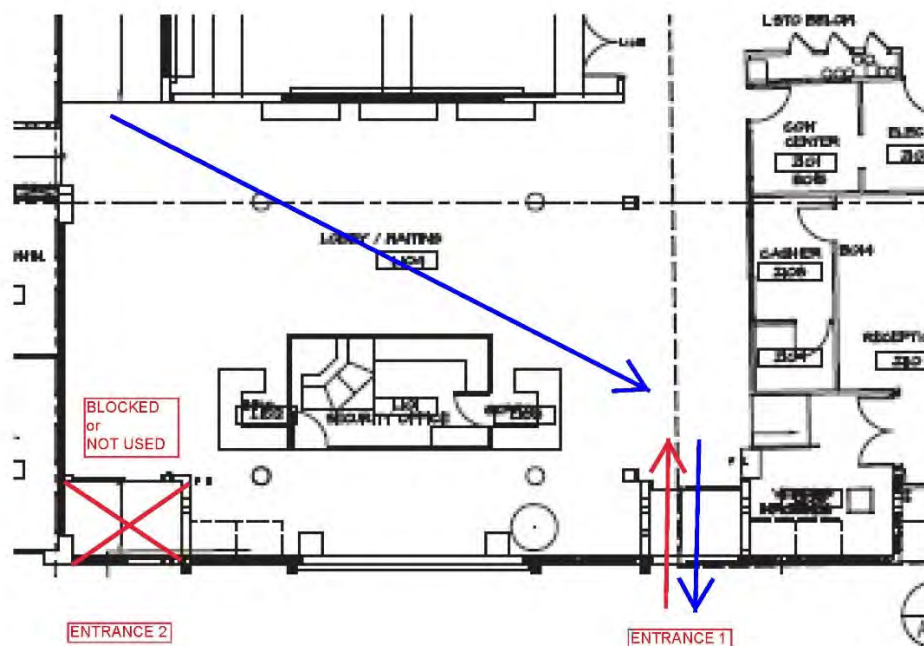
**Front Entrance/Vestibules:** The hospital front entrance vestibules has both an exterior and interior single sliding door configuration with possible break away feature. However, the door separation depth is only about 6 feet. Both sliding doors open simultaneously when someone approaches at either side (ingress or egress) allowing the hot, humid, moist outdoor air to gust/enter into the building. The arrangement, operation and separation does not function properly as both sets of doors are open simultaneously the majority of the time (duration of the day) due to the traffic conditions. The mechanical air curtain installed does not provide any assistance. The main contributor is that the second set of entrance doors, opposite side of the front entrance, are not in operation. This also significantly increases the egress capacity/occupant load at this single vestibule.

through. ABA specifies the distance between two hinged or pivoted doors in series shall be 48 inches minimum plus the width of the door swinging into the space or about 10 feet. ASHRAE 90.1 also requires a minimum distance of 7'-0" between closed interior and exterior vestibule doors. These minimum separation distance requirements are typically NOT sufficient. The automatic closing speeds of these doors can have a significant impact on door function, timing/sequence and passage. The distance separating the doors combined with a large number of personnel passing through, especially at shift change, can result in both sets of doors staying open continually. Vestibules are provided to reduce infiltration losses (or gains) from wind and stack effects by creating an air lock entry. This has been a recurring problem with most facilities. **PRIORITY Repair: Recommend (1) a building traffic study be completed to include "rush hour" entry and exit volumes to properly configure and size vestibules such that the automated doors are not continuously open. (2) both vestibules will need to be modernized to a greater depth (10 feet +/-) and install new doors, sensors for more ideal operation or sequence and possibly offset of doors/ opening (diagonal) in lieu of aligning. Alternative option for consideration would be a large revolving door with an emergency man door located at both entrances. EMERGENCY Repair: Recommend that the current closed, second vestibule be fixed and placed back in operation so one is dedicated to ingress traffic and the other egress. This would split the usage between two entrances, in lieu of one, reducing the wear and tear and air infiltration until they can be redesigned, reconfigured and updated.**

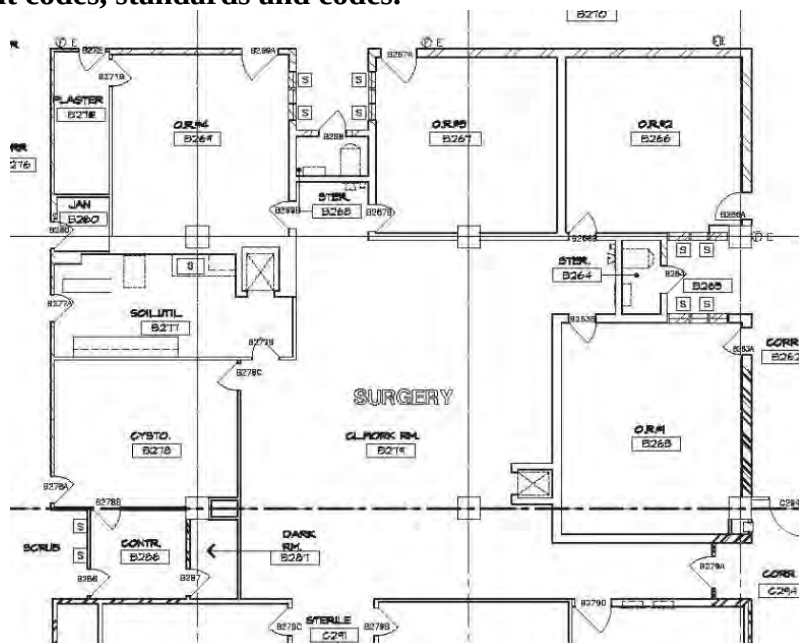
**OR Layout:** Although the current or existing OR room are functional, they are not compliant with today's newer standards for size, layout, clearance, equipment or flow as the design is outdated and does not comply with current codes or FGI guidelines. **MAJOR SCHEDULED REPLACEMENT (MSR) Repair: Recommend redesign of entire surgical**

**suite/department for better flow, adjacencies, space allocation and upgraded OR's to current codes, standards and codes.**

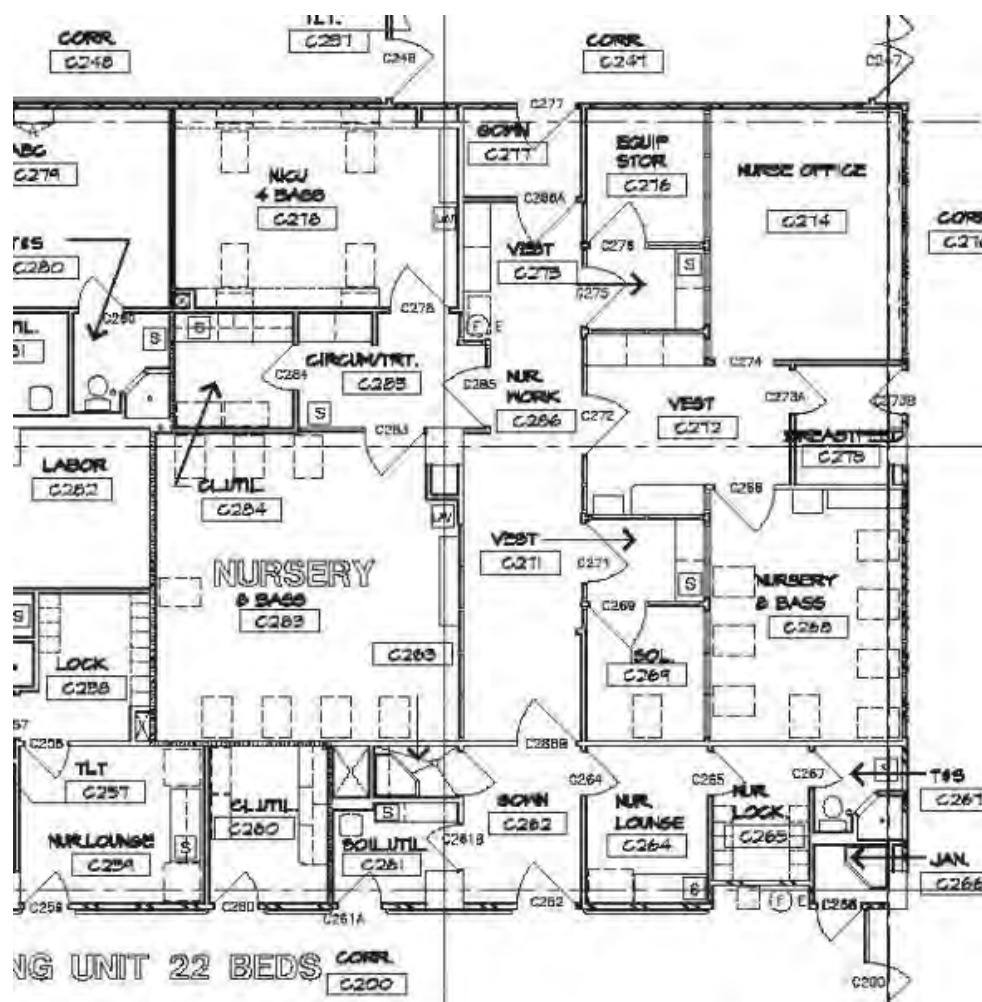
**NICU Layout:** Although the current or existing NICU rooms are functional, they are not compliant with today's newer standards for size, layout, clearances, equipment, light levels (controls) or flow as the design is outdated and does not comply with current codes or FGI guidelines. **MAJOR SCHEDULED REPLACEMENT (MSR) Repair: Recommend redesign of entire NICU suite/department for better flow, adjacencies, space allocation and upgraded nursery to current codes, standards and codes.**

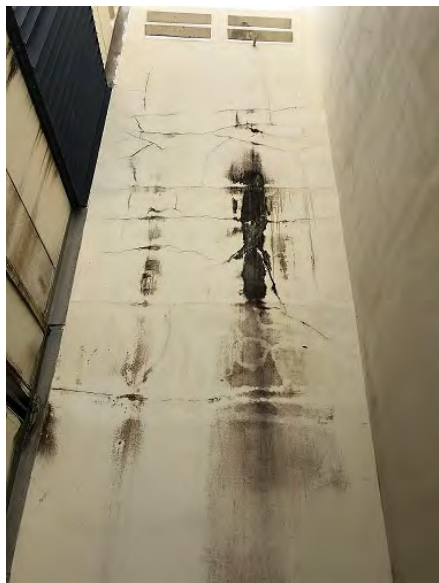
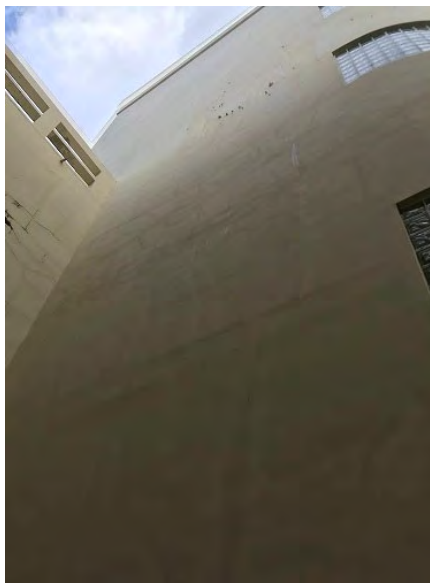
**Exterior Stair Walls:** Center stair enclosures (#2 & #3) at both north and south ends of building have infill poured in place concrete walls which have significant cracking issues and settlement. A project is currently underway replacing the glass block windows due to failure of rebar and leaks. **PRIORITY Repair:** Recommend that a full in-depth structural analysis be conducted on the walls and foundation supporting these stairs. The wall cracks may be injected with epoxy to bond and seal the cracks within the exterior wall. The foundation may need to be expanded/enlarged, reinforced and or even replaced. The foundations could be jacked up/lifted then added concrete could be added for stability and support meeting current seismic requirements.

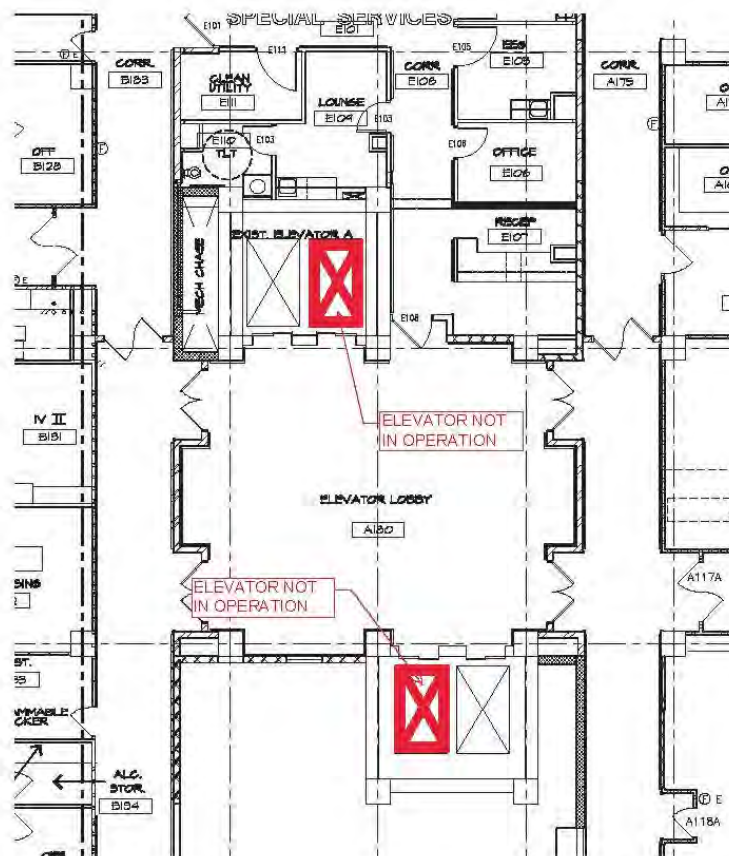
**Elevators:** Two of the four elevators for the facility were down, not working and under significant repair. Another was down for a short time for maintenance related repairs. The facility did have ISLM in place for the elevators. There is a current awarded project to modernize and replace the existing elevators (motors, gears, ropes, controls, etc.) and update the car/cabs to current standards. (LS03.01.50, NFPA, IBC, etc.) **PRIORITY Repair: Recommend getting this project started as soon as possible to get all elevators up in operation. Elevators are essential for moving patients to/from upper floors and critical departments. Keep all ILSM's in place throughout the construction phase.**

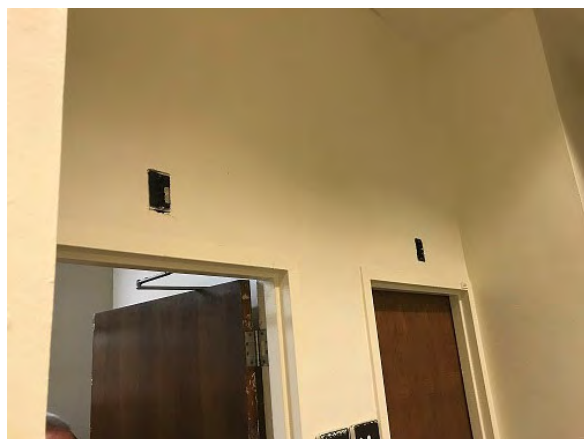
**Corridor Wall Penetration:** Open wall boxes located in corridor above toilet room doors (men and female). Corridor walls are to limit the passage of smoke per NFPA 101. When devices or other utilities are demolished they should be removed back to source and finished appropriately.  
**PRIORITY Repair: Recommend removal of wall boxes, wiring back to source and patch/paint walls.**

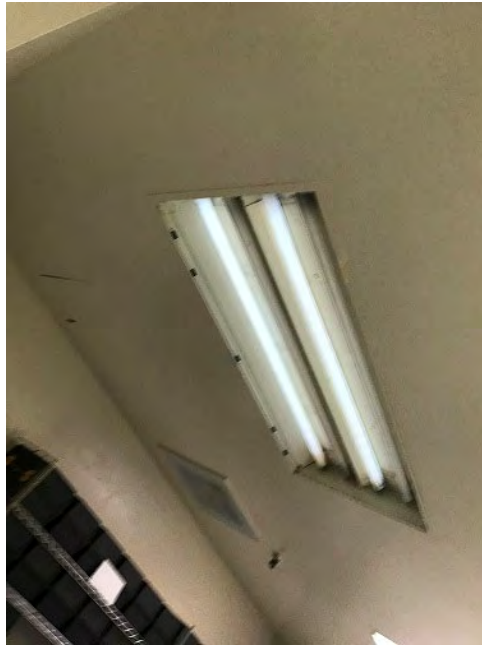
**Light Fixture missing Lens (Central Sterile Supply B151).** 2x4 light fixture in Central Supply does not have protective lens which has fluorescent bulbs exposed. Safety Risk. **PRIORITY Repair: Recommend installation of new light fixture lens for safety and Infection Control.**

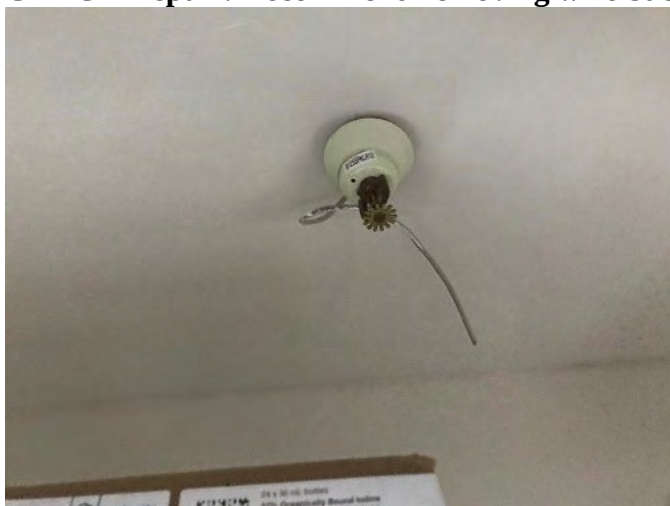
**Pharmacy Storage Closet (B122) Sprinkler Obstruction:** Supplies are stacked on top shelf of closes potentially blocking sprinkler. At least 18 inches of clearance is required to be maintained below sprinkler deflector to the top of storage. Perimeter wall shelving not located directly under a sprinkler head is permitted. Measurement is within the plane of the room – not a conical distribution from each head. (LS.03.01.35 EP 6 & NFPA 13 Section 8.5.5.3 & 8.6.5.2.1.1).

**EMERGENCY Repair: Recommend the removal of staked boxes so the 18 inch clearances are met.**

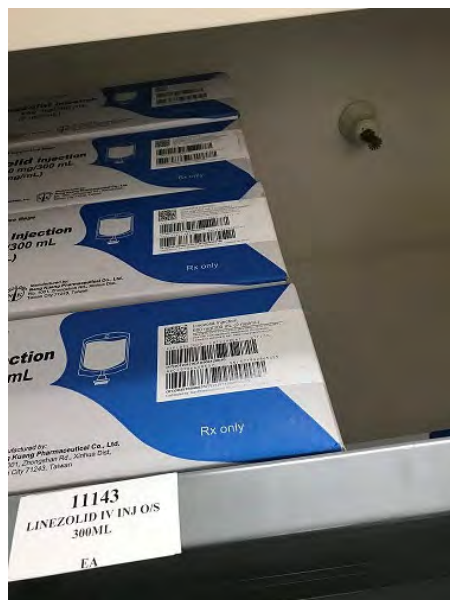
**Pharmacy Storage (B125) Sprinkler Clearance (18" Rule):** At least 18 inches of clearance is required to be maintained below sprinkler deflector to the top of storage. Perimeter wall shelving not located directly under a sprinkler head is permitted. Measurement is within the plane of the room – not a conical distribution from each head. (LS.03.01.35 EP 6 & NFPA 13 Section 8.5.5.3 & 8.6.5.2.1.1). **EMERGENCY Repair: Recommend Removing/reorganizing storage items on top shelf to comply with the 18 inch clearance requirement.**

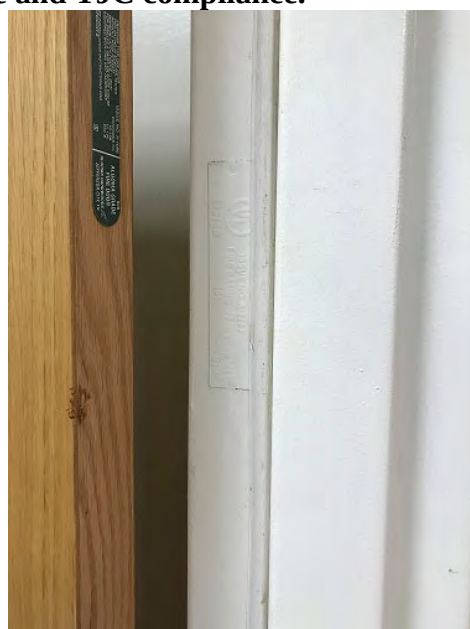
**ED Patient Toilet Nurse Call (A213).** Nurse call in patient toilet room does not have a dedicated nurse call light located outside the room at the corridor. Typically, NC lights are provided directly outside the room for quick visual identification. When the NC pull chord is activated it actually illuminates the corridor NC light at the end of the corridor at the

decontamination room. **PRIORITY Repair:** Recommend installing a NC light on the wall directly above this patient room door similar to all of the other rooms in this area.

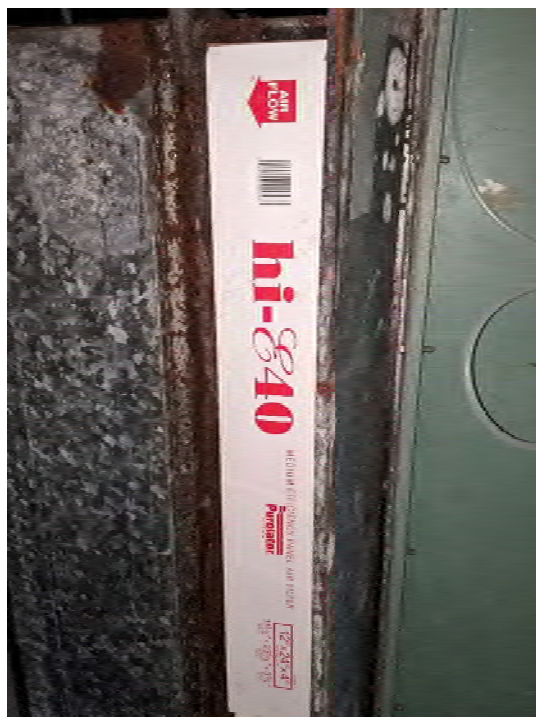
MERV 8 filter, typical of all air handling units observed.

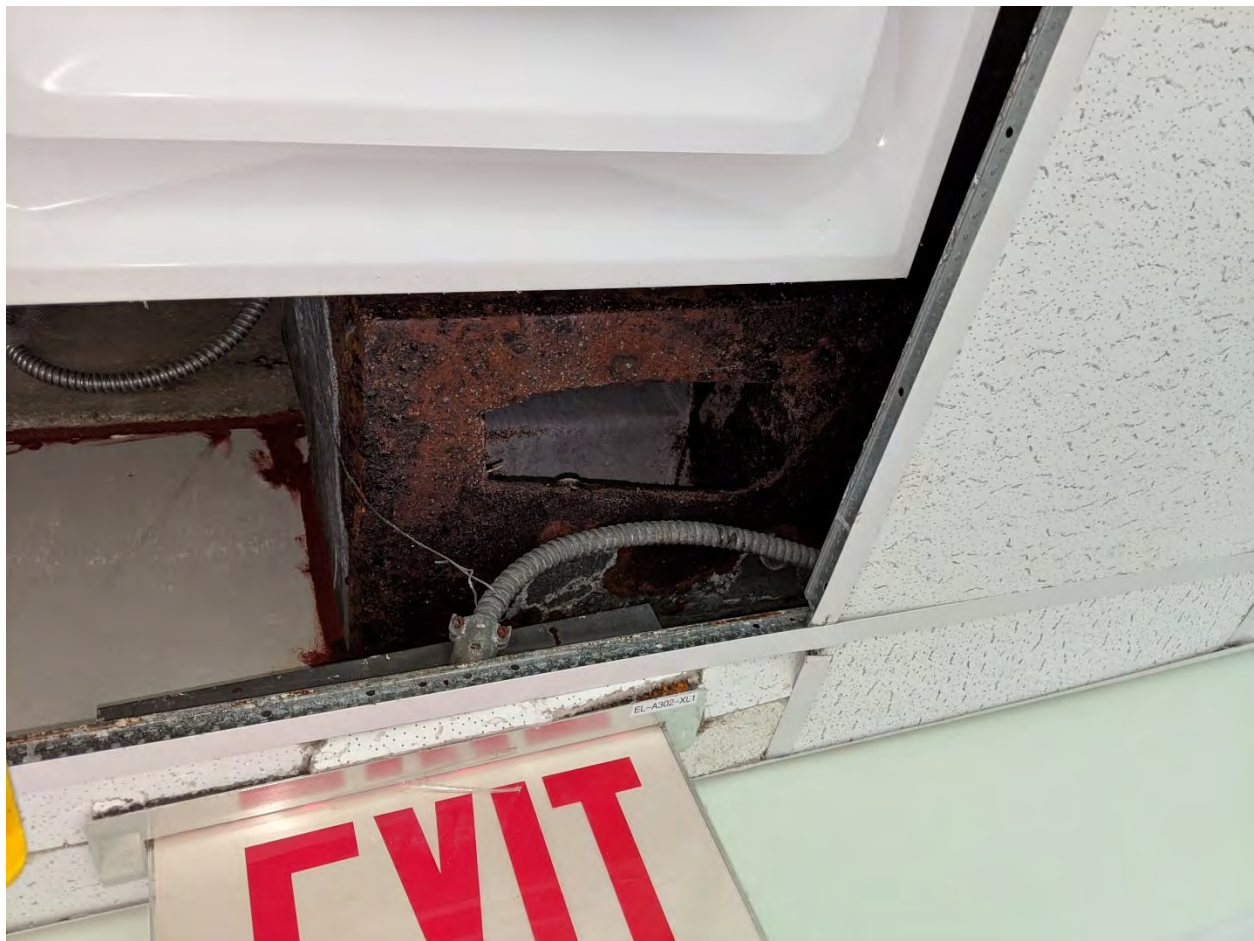
Corroded outside air ductwork drawing air from inside the building.

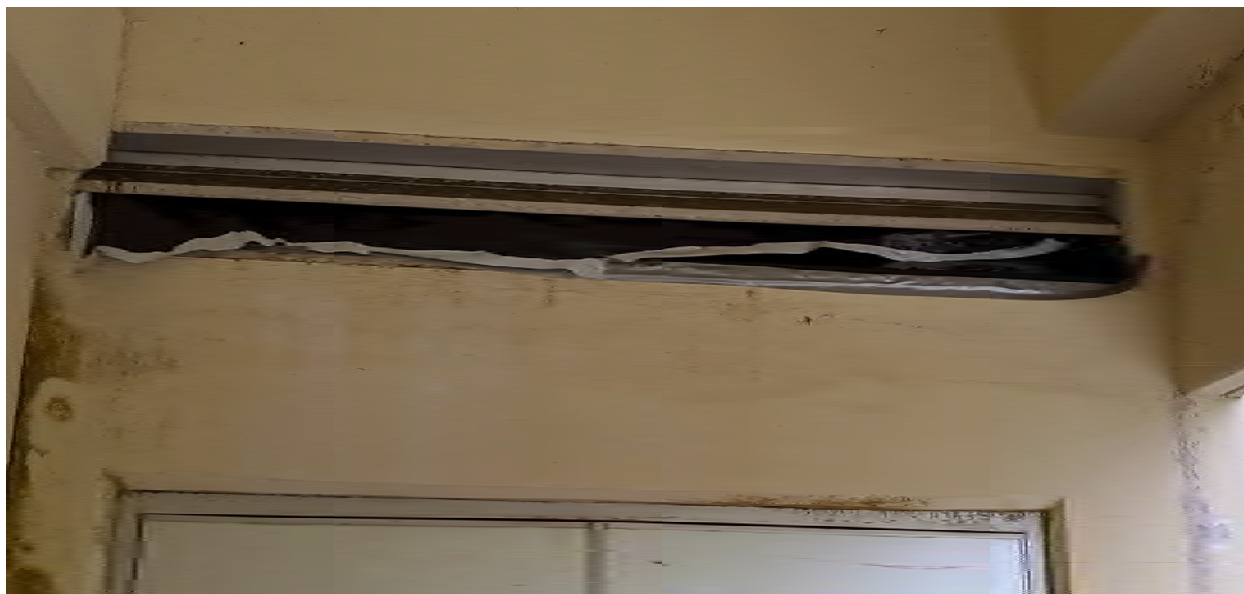
Blocked off outside air intake

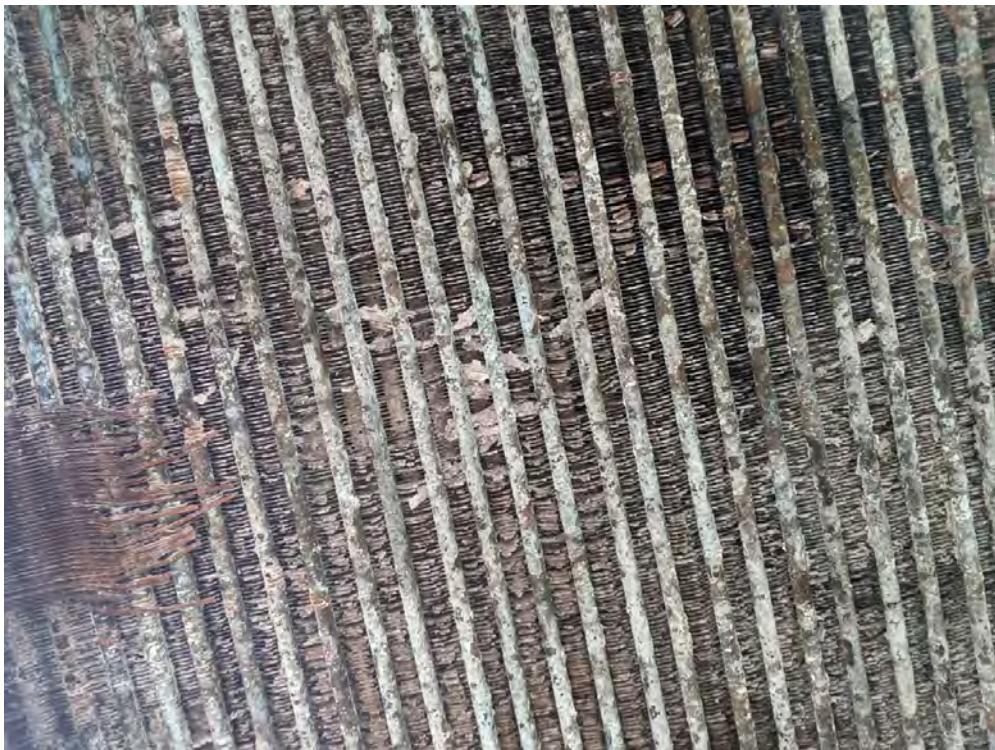
Corroded emergency chiller condenser coils

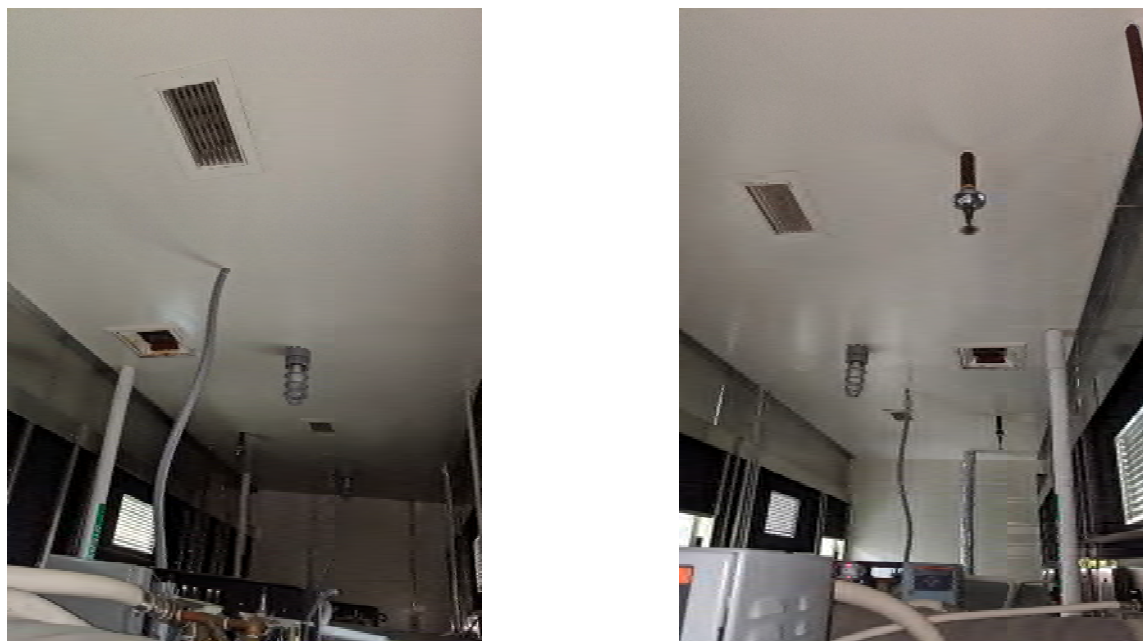
Inadequate exhaust in sterilizer equipment room

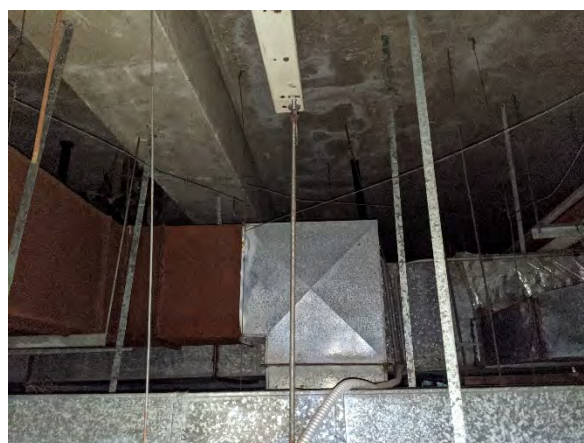
Inappropriate kitchen exhaust duct material

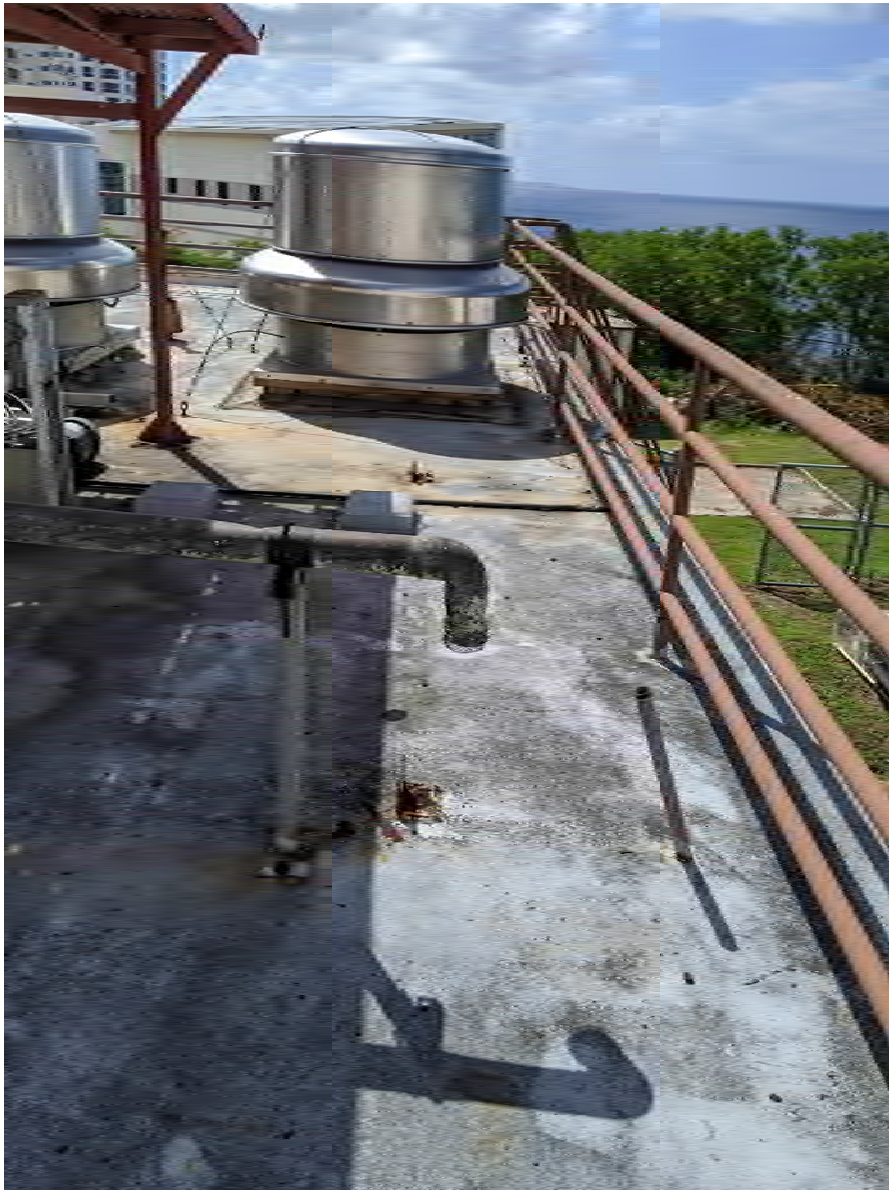
Medical air inlet closer than 25 ft. from exhaust fan discharge
