**US Army Corps  
of Engineers®**

**Facilities Condition Assessment  
Guam Memorial Hospital  
Tamuning, Guam**

**08 April 2020**

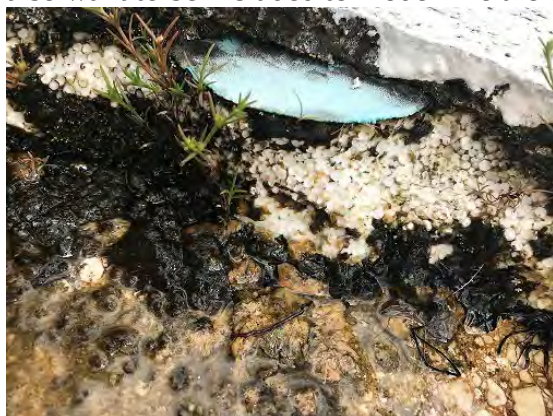
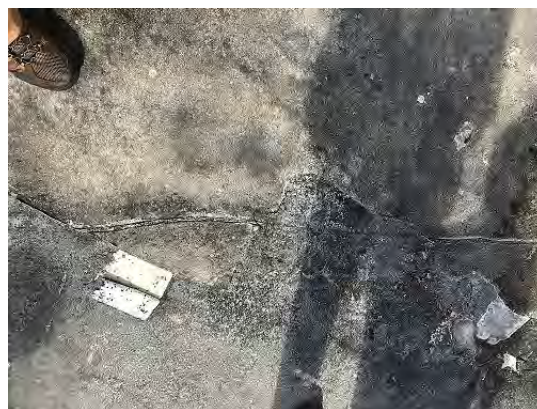
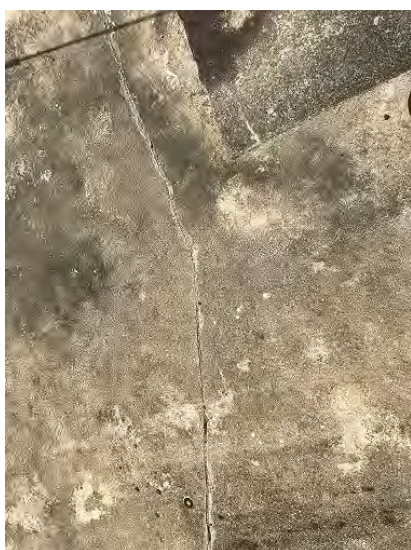
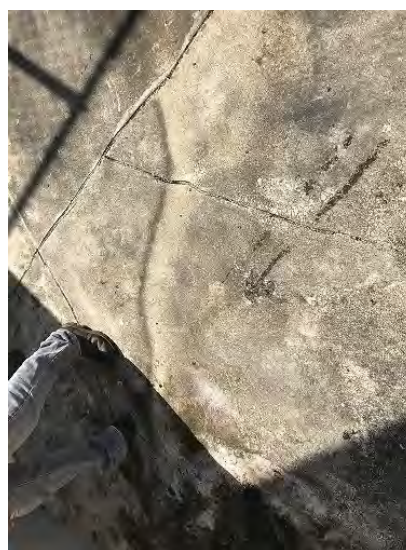
**Roof:** The roof is composed of Styrofoam (tapered insulation), with some sort of top membrane then 1/2 inch thick concrete topping with painted top coat installed over a flat structural concrete roof slab. Major cracking has occurred throughout this top layer allowing moisture to infiltrate. Moisture can cause roofing systems to degrade, lose adhesion, develop mold growth, curl and even lead to total system failure. Although the facility has attempted to repair, patch and recoat some of the damaged areas, the roof still leaks causing interior damage to ceilings, walls, equipment, etc. All Roofs should be replaced, to include the original A & B wings and E wing fourth floor. Roofing over the power plant as it was constructed sometime between 1978 and 1989. As well as all roofing of buildings built in 1989 (A-wing addition (D-wing), Entry Wing, S- wing, G-wing and M-wing) should be replaced. C-wing roofing was replaced in 2000 but may also want to be included to modernize the entire facility.

**PRIORITY Repair:** Recommend removing entire roof system down to structural slab. Dry, repair, caulk, seal, waterproof and skim coat structural slab for flat level surface. The roof system selection is an integral part of the overall building design and must take into account interior building usage and climate. When dealing with existing structures, weight, slope, existing and hazardous materials, and historic preservation may become constraints. For example, the thickness, weight, and reflectivity of the roof system has a major impact on roof/structure as already designed. Further, with an occupied building, construction noises, fumes, fire hazards, and roof access all take on increased importance. Other considerations that must be followed are determination of wind uplift pressures (corners, perimeter, or field), thermal expansion, environmental corrosive conditions, humid location based on ASHRAE climate zone, air and vapor barriers and integration with building envelope.

**Install a new elastomeric membrane roofing system with new tapered rigid insulation a minimum of 1/2 inch per foot slope. When increasing slopes of existing roof decks, clearances for rooftop structures such as curbs, base flashing, access doorsills, etc. must be increased as well which can impact facility operations and increase cost.**

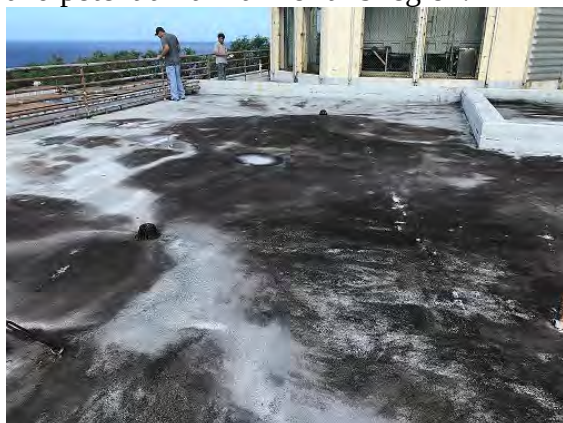
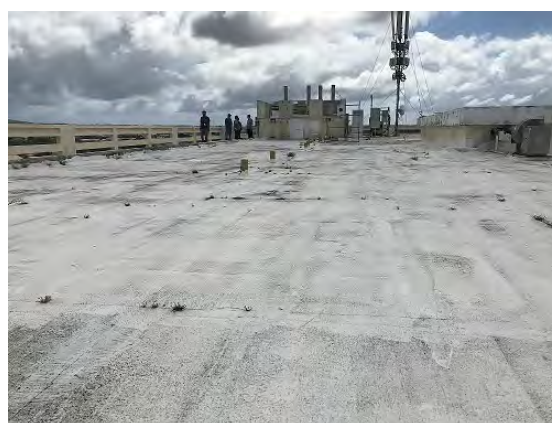
**Roof Slope:** The slope is very minimal to non-existent in most areas on the existing roof at the facility with the exception of the more recent ER and ICU additions (2014). Poor water drainage and ponding is quite evident with discoloration. Appropriate slopes are a minimum of 1/4 inch per foot to more appropriate and recommended 1/2 per foot which is ideal for positive drainage and potential rainfall for this region.

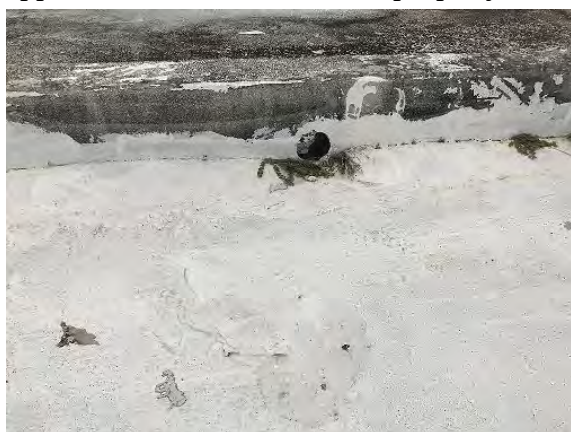
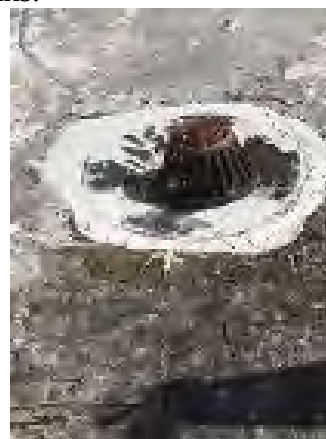
**Roof Drains:** Roof drains consist of primary on roofs with scupper secondary which drain down the sides of the building. Drain caps are corroded, broken or even missing, top coat does not appear to be flashed or sealed properly with high risk of leaks.

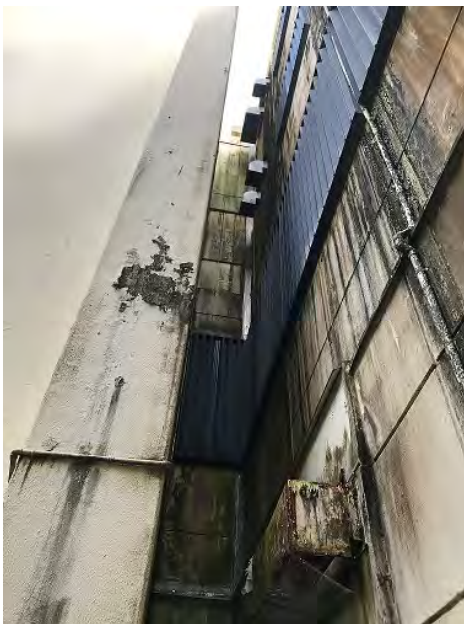
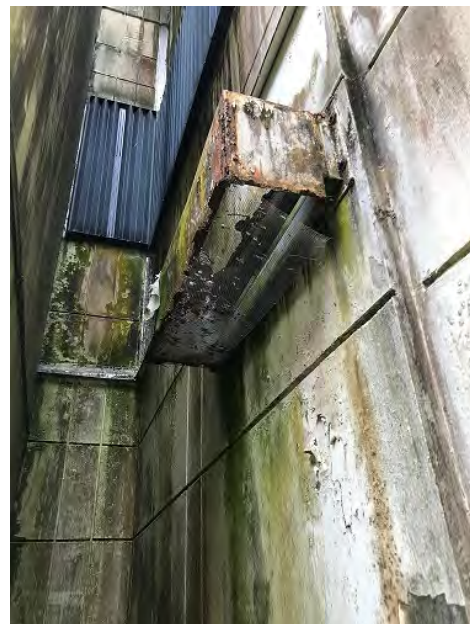
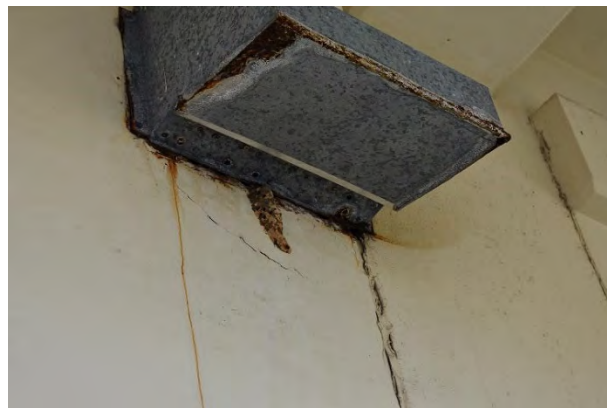
**Exterior Wall Openings/Penetrations:** The building envelope is severely compromised with numerous penetrations from fresh air intakes, abandoned intakes, exhaust (ISO), expansion joint to possible flashing failures. The corrosive environment has eroded not only the shroud/covering, the joint seal at the building opening and duct on almost every intake, but has also impacted the failure of the interior duct leg inside the building (5 to 20 ft). As a result, a

number of the intakes exterior shroud/covering have been removed and then covered. The courtyard exterior walls have numerous abandoned air transfer grilles/ducts thru the exterior walls that the moist humid air infiltrates into the building. Along with other fresh air intakes for AHU on the upper floors, pharmacy exhaust, isolation room exhaust, etc. All have penetration impacts to the integrity of the exterior envelope. These openings allow hot humid/moist outdoor air to enter the plenum area or building. With the exterior wall not adequately sealed at these locations the AHU or occupied space cool air mixes with the hot humid air which generates moisture, condensation and mold growth above the ceiling, on the ceiling, within walls and throughout the building. **PRIORITY Repair: Recommend sealing all penetrations, replace fresh air intakes with more appropriate material for environment along with joint/seal, etc. See Mechanical for additional information.**

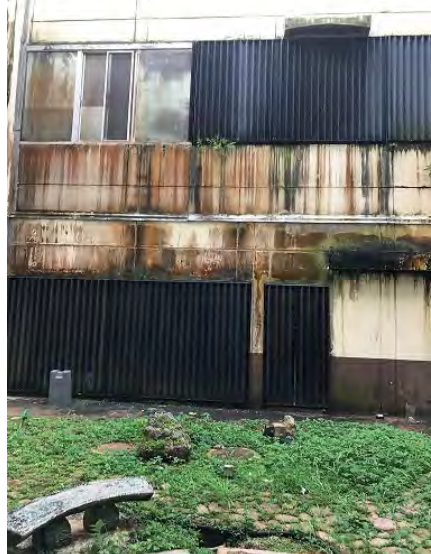
**Exterior Windows:** Exterior windows are generally in FAIR condition, constructed with single pane (fixed glass) aluminum framed systems either storefront or punched styles throughout the facility. All windows have a steel framed horizontal sliding metal (typhoon) accordion type

shutter system at the exterior. Numerous window sills have rot/decay/deterioration/water damage which appear to be leaking and should be replaced. Others have failed seals or gaskets. Windows that fail or are improperly sealed can cause heat and humidity to seep in, resulting in a rise of interior temperature, which will cause air conditioners to work twice as hard to keep the environment cool. This also creates moisture issues that can lead to the growth of dangerous substances such as mold.

**PRIORITY Repair:** Recommend removing all of the existing windows across the entire facility and install newer high efficient non-operable (Fixed) Windows. High quality (marine grade, Kynar finish or stainless steel) aluminum framed windows are common, material is lightweight, strong, energy efficient and require little maintenance. Ensure that

**the window framing system has a thermal break (i.e. nylon I beam) which prevents the frames from conducting heat/cold and eliminates condensation. Insulating laminated glazing units enhances acoustical performance, ultraviolet light protection and the laminated component is designed to remain integral in the opening should glass damage occur at the exterior layer. UV resistant and provide added protection for impact resistant glass for severe weather or blast protection. The glazing should have a low coefficient rating, multi-paned and low emissive glass (low-e coating) with glass panes bonded with a polyvinyl-butyl (PVB) interlayer.**

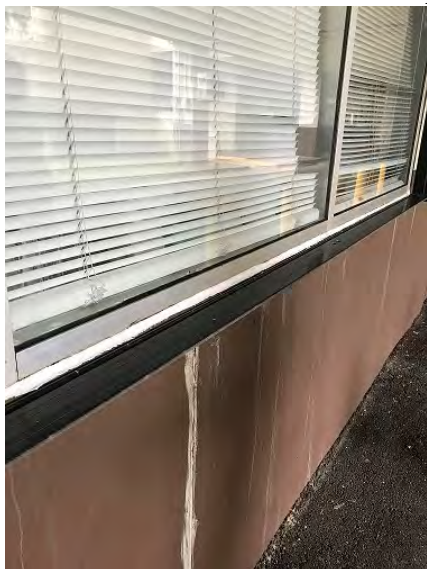
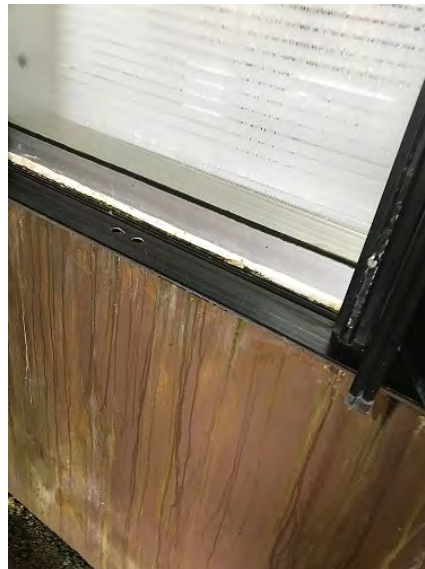
**Exterior Windows (Flashing/Weeps/Caulk):** Window sill flashing not provided and weeps at exterior are either not existent or sealed with caulk. Most architectural aluminum glazing system are not designed to be totally waterproof. Rather, most systems are designed to control water infiltration under extreme conditions and weep that water back to the exterior. Punched windows, storefront and curtainwall systems differ in many ways: appearance, profiles, wind loads, glazing, thermal performance and how they weep water. **Punched window** can be

operable or fixed which are located in a hole-like or predefined opening within the exterior wall. The most important consideration to understand is whether the window system is a rain screen or barrier system. A rain screen system provides internal drainage (weeps) for water that infiltrates into the system while a barrier system assumes that no water will ever infiltrate and does not need internal drainage. Fixed windows of course off the best resistance to air infiltration or water penetration and require less maintenance. **Storefront systems** control water infiltration by directing all moisture to the sill pan. It is imperative that the sill pan be installed correctly. Most manufacturers have prefabricated or can provide custom sill pan components with integrated end dams. Without end dams, water will intrude into the jamb locations of the building. Window perimeters should have flashing (head and Jamb) that are integrated with the waterproofing at adjacent walls. Water deflectors must also be installed wherever a horizontal mullion occurs. These direct water over to the vertical mullion where it weeps out at the sill flashing. Deflectors are necessary to ensure that the water bypasses the glass lite. Without water deflectors, moisture is likely to settle on the top of the glass, allowing water to enter the interior and causing possible failure of the glass unit. **Curtainwall systems**, we want to prevent water from reaching the vertical mullions. Each horizontal mullion must have zone dams properly installed and sealed at the vertical members. Any water that makes its way to the vertical mullion will ultimately make its way to the interior of the building. Unlike storefront, which directs water to the sill, curtainwall weeps water at each individual lite of glass through holes in the pressure plate. Because curtainwall systems are used for taller elevations with higher wind loads, the amount of water entering the system is typically greater than the capacity of storefront systems. This is why each lite of glass is individually weeped. Since water is not diverted down the vertical mullions to the sill, curtainwall does not require sill flashing. However, extreme care must be taken into consideration when installing caulk joints at the sill. The exterior caulk joint must be behind the face cover since water is weeping out of the bottom.

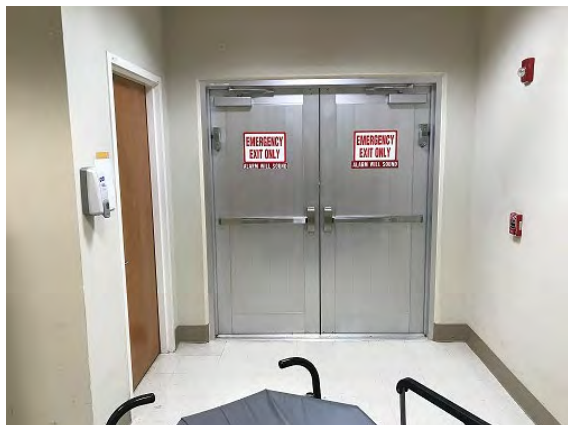
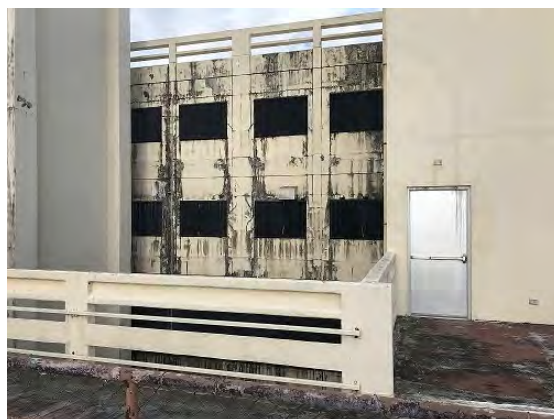
**Exterior Doors:** Exterior doors have a mixture of either aluminum or hollow metal. Majority of the original building doors are in GOOD condition. Typical door frames are hollow metal. The only issue identified are failed seals probably due to exposure and corrosive environment. A couple of the overhead doors at the central utility plant also needs to be replaced due to condition and damage. **PRIORIT Repair: Recommend replace all man door seals, recondition hardware to either full replacement of overhead coiling CUP doors to reconditioned (oil/lubricate) to replace latches, wheels, bearing and coil springs.**

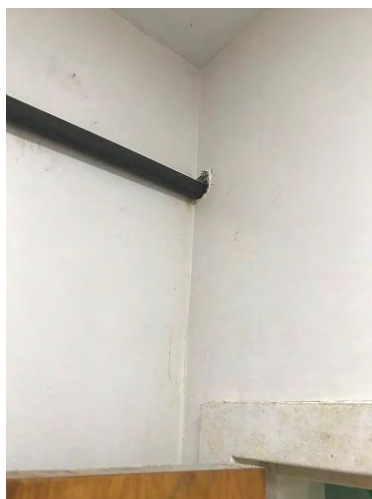
**PT Storage Room/ Janitors Closet (A110) Wall Penetration:** The wall mounted AC unit located on the north wall of Exercise A111 has a condensate drain line that routes through the wall and down to the floor sink. Walls are required to limit the transfer of smoke. **PRIORITY Repair: Recommend to seal penetration (both sides) with caulk to prevent the transfer of smoke.**

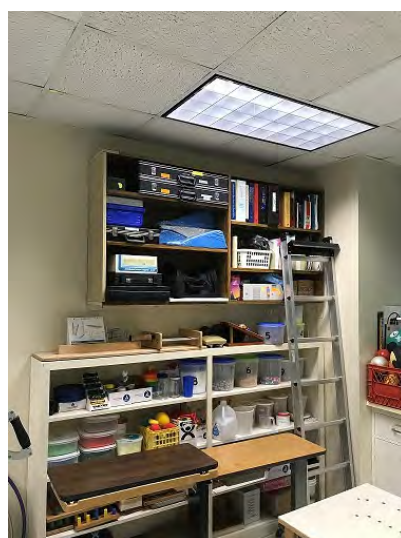
**Wall Cabinet Tops/Closures:** Numerous locations around the facility within healthcare occupancy had wall cabinets without any sloped tops or vertical enclosures to ceiling. Healthcare occupancies require for not only cleaning purposes due to access/reach and infection control with dust, debris accumulation but also to restrict or prevent stacking, that some sort of closure at wall cabinets be provided. (Example locations include: PT Treatment A113, Central Sterile Supply B151, Decontamination B158, ICU/CCU Treatment Rooms, ED Soiled Utility A281, CT, Mammo, Ultra Sound and others. **PRIORITY Repair: Recommend to install appropriate sloped tops at all wall cabinet locations or plastic laminate enclosures to/thru ceilings. This could not only lead to an OSHA violation, in stacking items on top of shelves above a certain height. Reaching to remove items from the tops of shelving can cause strains or other injuries that can lead to employee absence or worker's compensation claims. A safety hazard. It is common practice to provide enclosures at the top of wall cabinets, lockers and other shelving.**

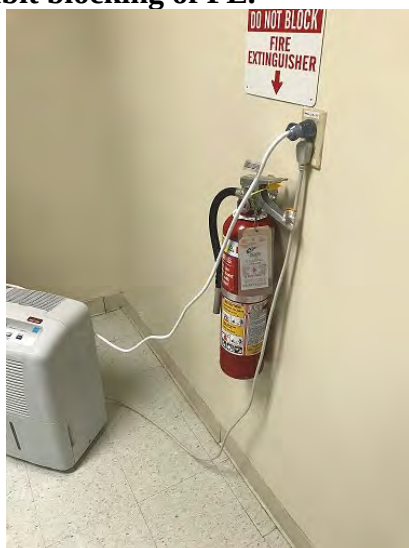
**Fire Extinguisher Obstructed (Central Sterile Supply B151).** Fire extinguisher obstructed with electrical cords to humidifier or other equipment. **EMERGENCY Repair: Recommend relocate equipment to prohibit blocking of FE.**

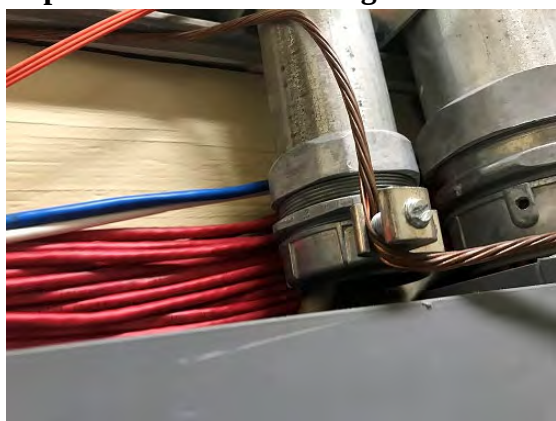
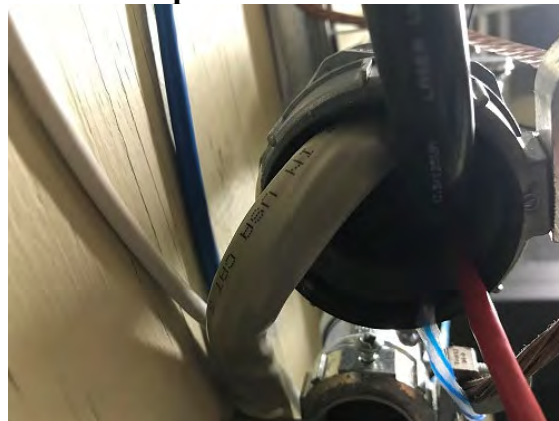
**ICU/CCU COMM Room (B293) Conduit:** Conduit on the far left actually routes up and then horizontally through the corridor wall, but not sure where it goes. The perimeter walls for this room are 1 hour rated, protection. This conduit needs to be sealed at the bottom. **PRIORITY Repair: Recommend filing the bottom of pipe with Hilti or equal rated caulk.**

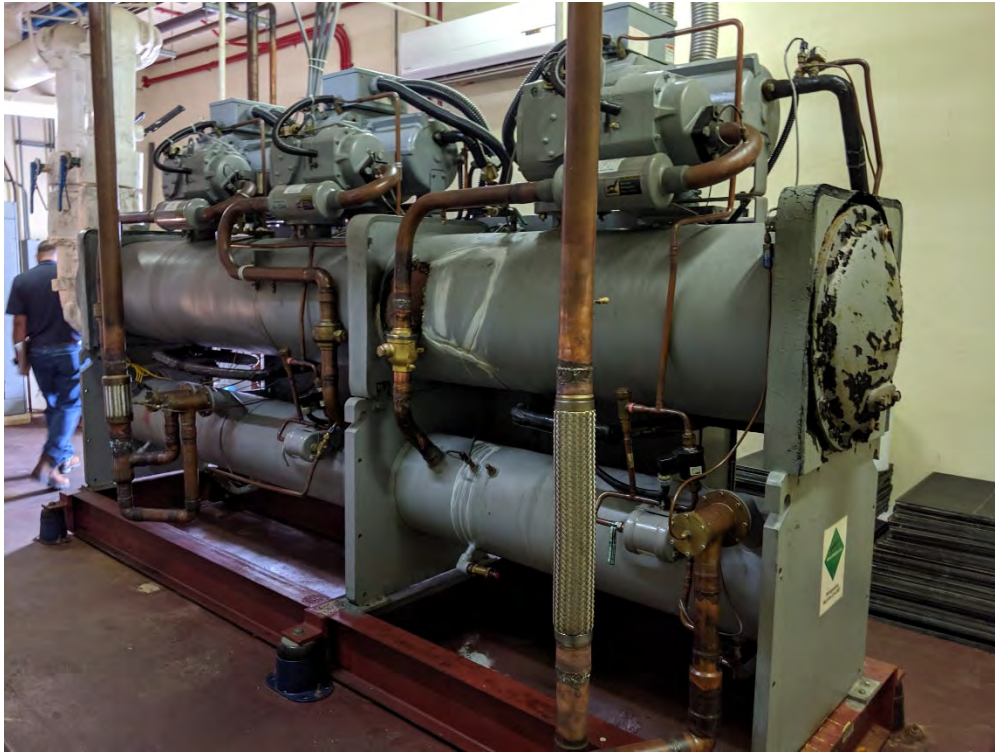
Emergency chiller

The emergency air-cooled chiller has three compressors and three remote air-cooled condensers with common refrigerant piping. While the emergency chiller is tested regularly, and appears to be operational, the condensers are severely corroded from exposure to the salt spray. The inlet side of the aluminum/copper fin-tube coil is completely corroded to just past the first row of copper tubes. It is only a matter of time before the coils are corroded to the point that high refrigerant head pressures prevent the chiller from operating at all. Based on the level of corrosion observed, the condensers are nearing the end of their usable life.

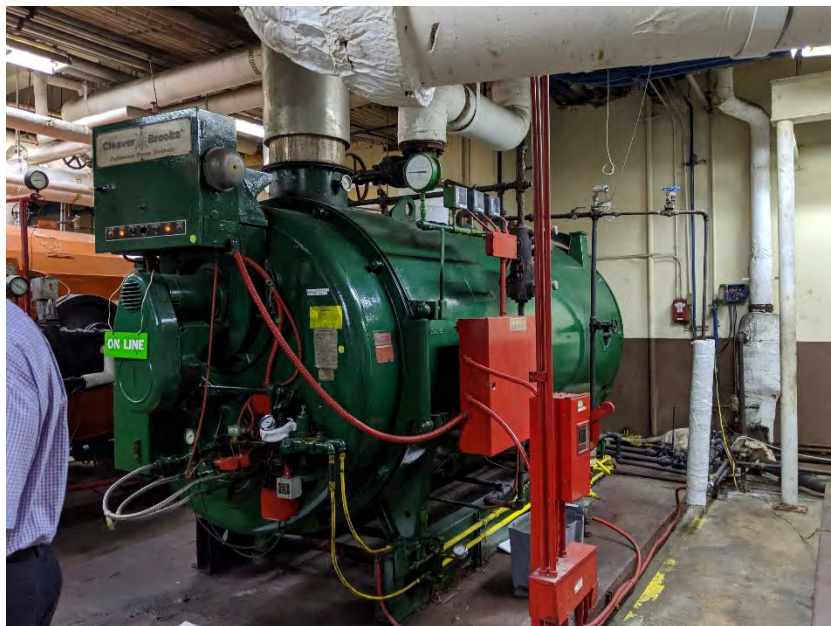
Steam boiler

**Steam** - Steam is provided by two 125 HP (4300 lbs/hr) diesel fuel fired boilers operating at 75 PSI. Steam is utilized for sterilization, and to generate domestic hot water. One boiler is currently out of service for re-tubing. The tubes in the other boiler are planned for replacement once the one currently being worked on is operational. The boilers are in excess of 25 years old, exhibit significant exterior corrosion, and are beyond their useful life. In addition, when the boiler restarts at low load, significant smoke is produced. This continues for several minutes. Repair/renewal of the facility would require replacement of the boiler system. The boiler feedwater/condensate recovery tank is severely corroded, leaking, almost non-operational, and beyond repair. Complete replacement is the only viable remedy.

Replacement of the boilers should also consider inclusion of a pressurized deaerator for feedwater treatment to reduce corrosion in the steam system.

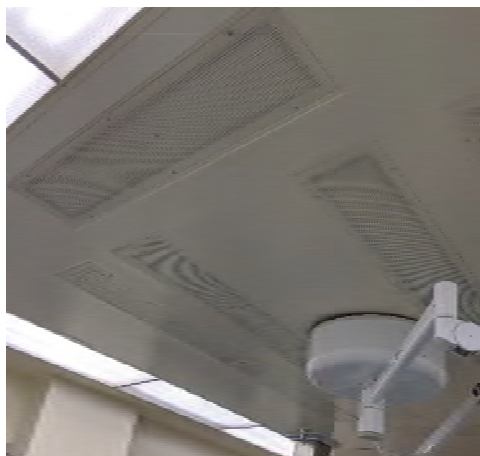
**Surgical Department** – The surgical department, with the exception of operating room #2, is served by a single 100% outside air constant volume air handling unit. Operating room #2, which is currently not being used, is served by AHU3 that also serves the ICU common areas. While space temperatures within the ORs were reported as within requirements, portable dehumidifiers were being used to keep the space humidity within limits. This is likely due to the lack of reheat in the AHU's serving the ORs. Without reheat it is difficult, if not impossible, to lower the humidity without overcooling the space as described above. In addition, the air supply to the ORs does not comply with current industry requirements (ASHRAE STD 170) since the unidirectional low aspirating diffusers do not cover at least 70% of the ceiling space above the surgical table and extend 12 in. on either side.

OR ceiling showing inadequate coverage

7. The steam boilers require replacement. Due to the age of the steam system, a complete steam system replacement should be considered.
8. The surgical department needs a complete HVAC renovation to provide the air change rates, filtration levels, and sterile field delivery concept required by ASHRAE STD 170. An analysis of system psychrometrics is required to keep OR humidity within limits without the use of portable dehumidifiers. A supply air dewpoint of 47F is recommended.

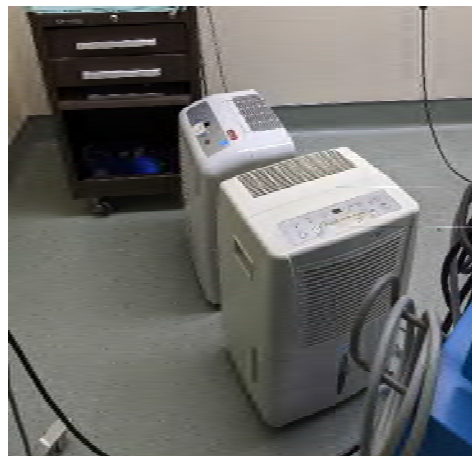
Portable dehumidifiers being used in ORs

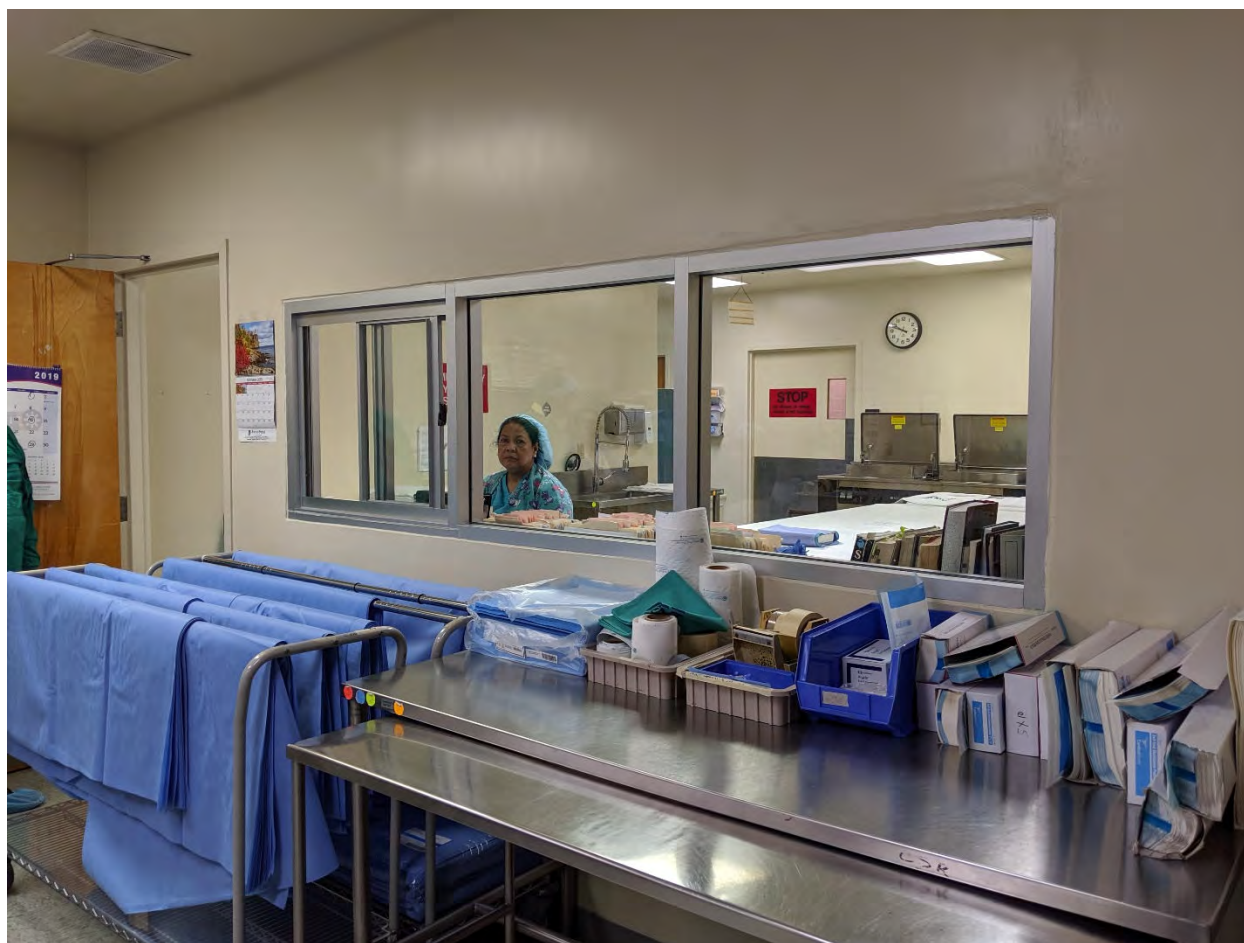
**CMS (Central Sterilization)** – The central sterilization department is not compliant with current industry guidelines (FGI/ASHRAE STD 170). FGI now requires at least a two room suite with the decontamination area separated from the clean workroom (assembly/prepack) and sterile storage by a building partition. There is currently a wall between the decontamination area and the clean workroom. However, since the pass through window is not large enough to accommodate most of the items/containers processed, the door between the spaces is being propped open and the items carried through the doors. While not specifically required by criteria, typical industry practice is to provide double sided pass through washers between decontamination and the clean work room, similar to the pass through sterilizers between the clean workroom and sterile storage. In addition, a pass through window is typically provided to accommodate those items that would not be processed through the washers. With the door between the decontamination area and the clean workroom being propped open it is impossible to maintain the ASHRAE STD 170 required negative pressure in the decontamination area and the positive pressure in the clean work room.

Sterilization clean workroom with decontamination beyond

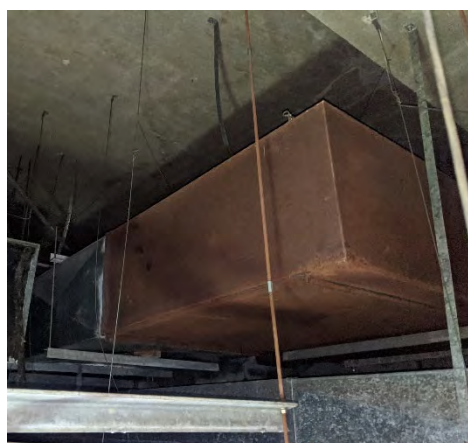
**Kitchen** – In addition to the inoperative make-up air unit mentioned previously, at least two sections of the kitchen exhaust hood grease duct have been replaced with light gauge galvanized metal as opposed to the NFPA 96 required 16 ga. black steel or 18 ga. stainless steel. While this is not an immediate threat to life or health, in the event of a cooking fire, the exhaust duct may not effectively contain the fire within the exhaust system. At a minimum, the non-compliant kitchen exhaust hood duct sections should be replaced with materials that comply with NFPA 96.

Inappropriate kitchen exhaust duct material

1. The non-compliant light gauge galvanized ductwork needs to be removed from the kitchen exhaust and replaced with 16 ga. welded black steel to comply with NFPA 96.
2. The kitchen make-up air system needs to be repaired and placed back in service.
3. All HVAC systems need to be evaluated and renovations/repairs made to provide ASHRAE STD 170 minimum outside ACH rates.

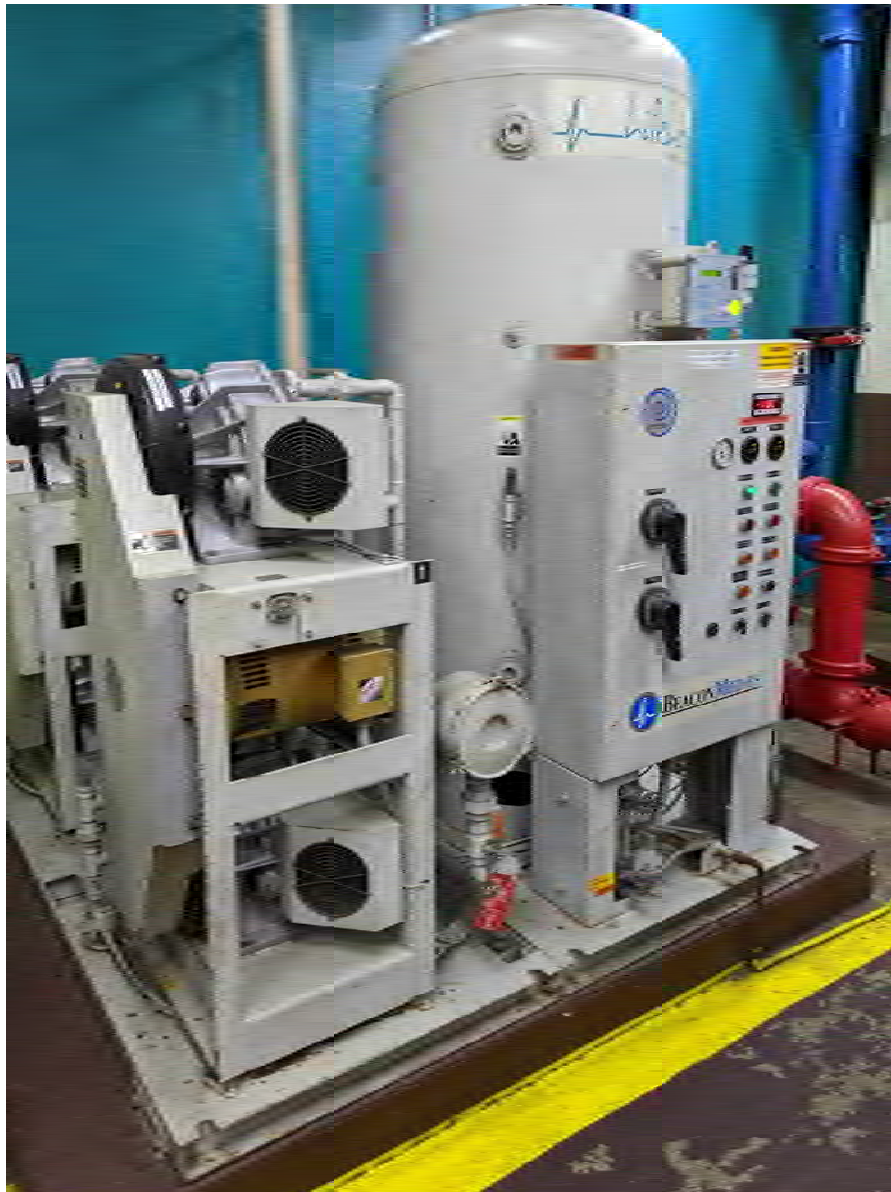
Medical air compressors with 20,000 gal water tank beyond

**Medical Air (MA)** – Medical air is provided by a BeaconMedeas quadraplex oil-free dry scroll compressor system. This system was installed in 2008 and is in good working condition. The medical inlet is located closer than 25 ft. from the central plant exhaust fan discharge. NFPA 99 requires that medical air inlets be located at least 25 ft. from ventilating system exhausts, fuel storage vents, combustion vents, plumbing vents, vacuum and WAGD discharges, or areas that can collect vehicular exhausts or other noxious fumes.

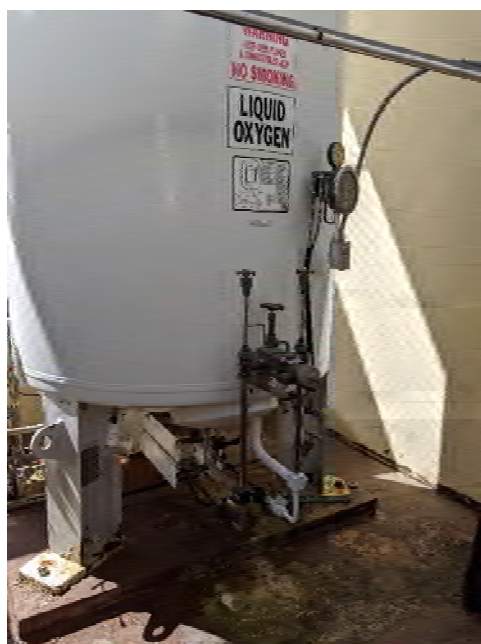
**Oxygen** – There are two bulk oxygen systems located in the detached medical gas compound. System #1 was installed in 1996, and is not currently in service. System #2 was installed in 2004 and is in working condition. Reserves are provided by a cylinder manifold system also located in the medical gas compound. There is no emergency oxygen connection provided on the exterior of the building. NFPA 99 requires an emergency oxygen supply connection anytime the oxygen supply is not located within the building and within building reserves are not provided. Since both the primary and reserve supply are located remote from the building, an emergency oxygen supply connection is required.

Oxygen system #1

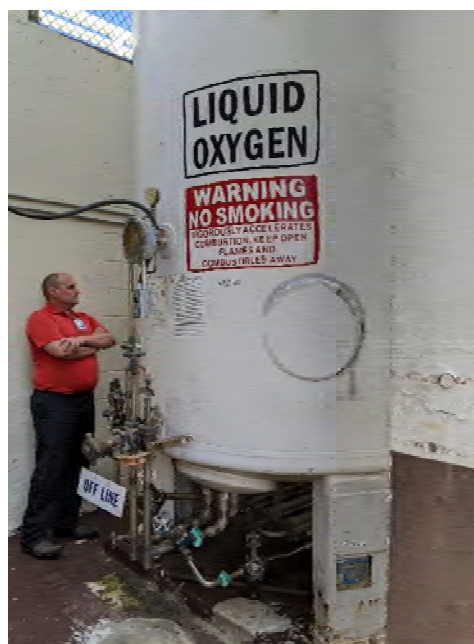
Oxygen system #2

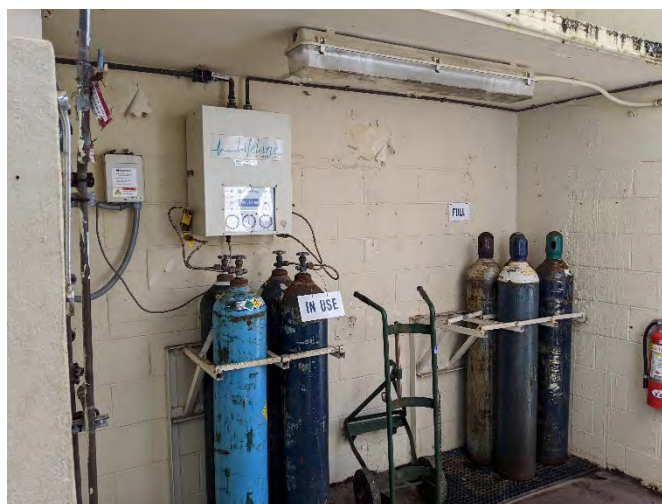
**Nitrous Oxide** – Nitrous oxide is provided by a primary/reserve cylinder manifold system located in the medical gas compound. This manifold system is in good working condition.

Nitrous oxide system

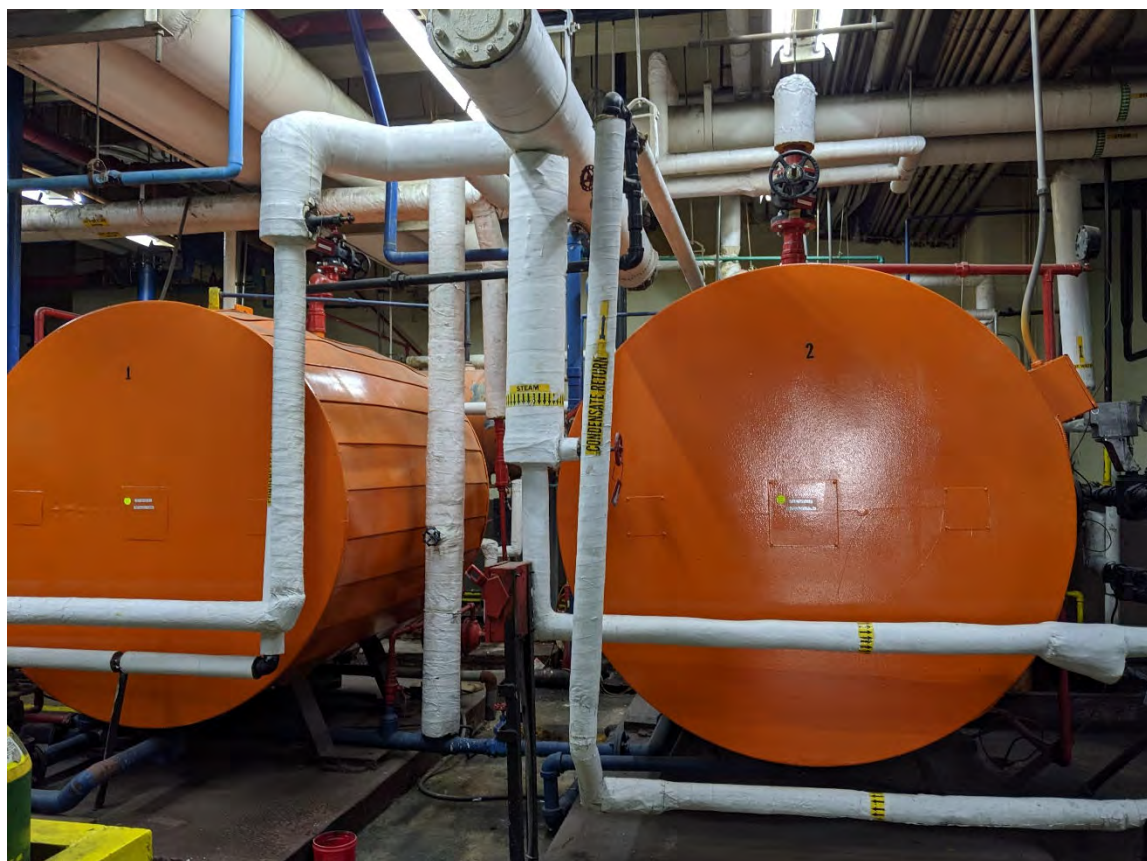
Domestic hot water is generated by steam to water heat exchangers at the CUP and distributed to the hospital. It was indicated that the generation temp and supply temp is 140 deg F. While the actual water temperature delivered to the faucets was not checked, a few hand washing locations were operated, and hot water was available within a reasonable time (around 30 seconds).

Domestic hot water heat exchangers
